Following is the progress report for the Bailey Farm Divco Dairy truck restoration project for the week of 28 July 2019. Please refer to the attached photos. We have also incorporated all photos and this report into a PDF document for ease of review.

Bailey Farms Divco Dairy Truck Restoration Photos Week of 28 July 2019

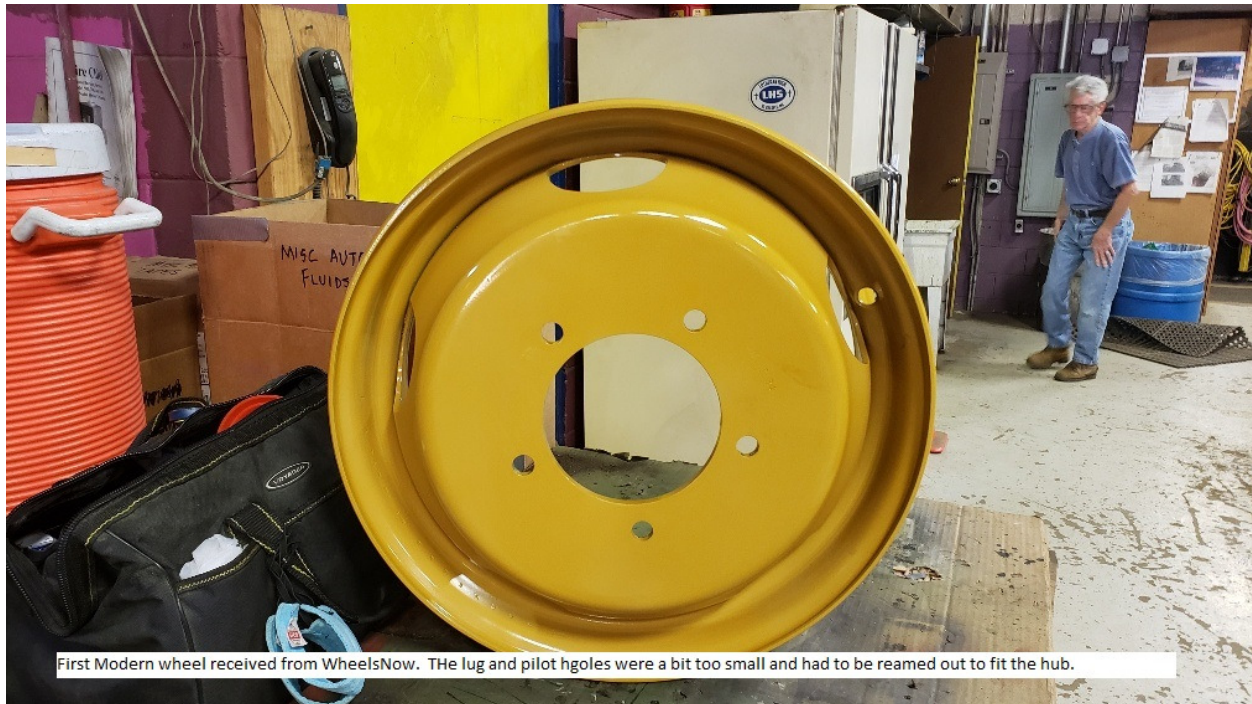
First Modern wheel received from WheelsNow. The lug and pilot holes were a bit too small and had to be reamed out to fit the hub.

We received and fitted the first modern wheel received from WheelsNow of Waukesha, Wisconsin. The lug holes and the pilot hole were all slightly too small, and had to be enlarged with a die grinder before the wheel would fit the truck's hubs. We plan to ask WheelsNow to make the holes all slightly larger, if possible.

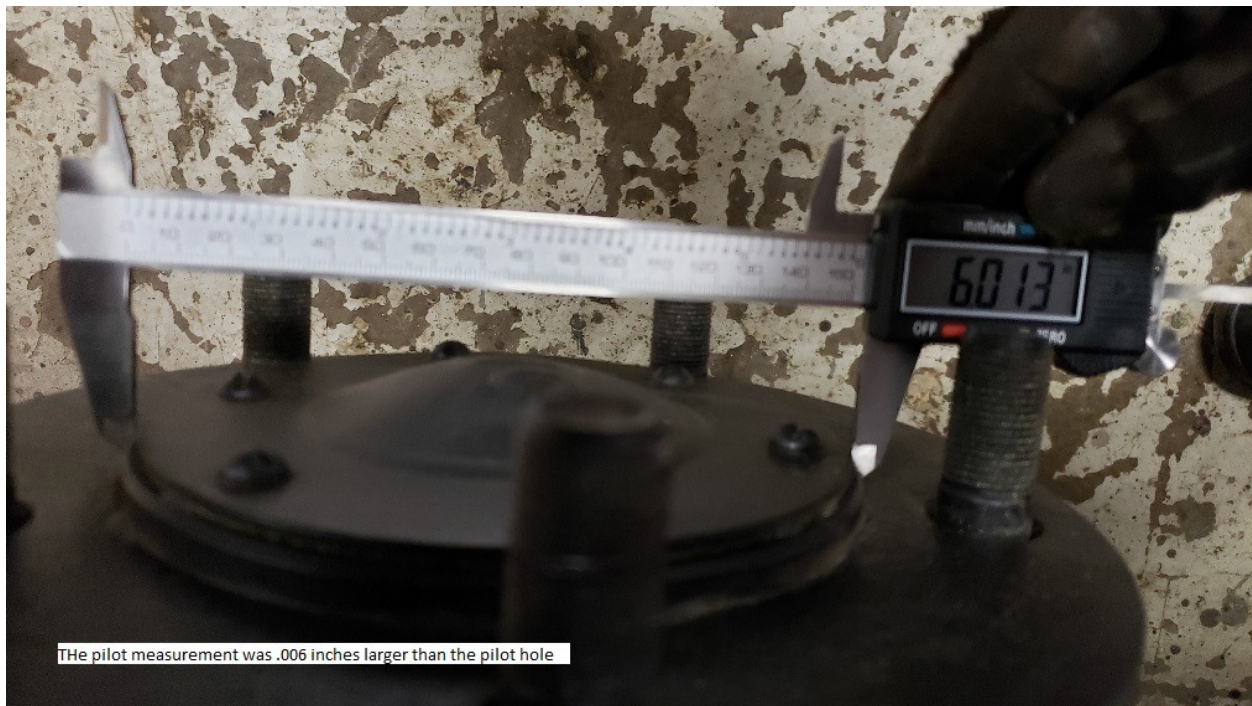
The pilot measurement was .006 inches larger than the pilot hole

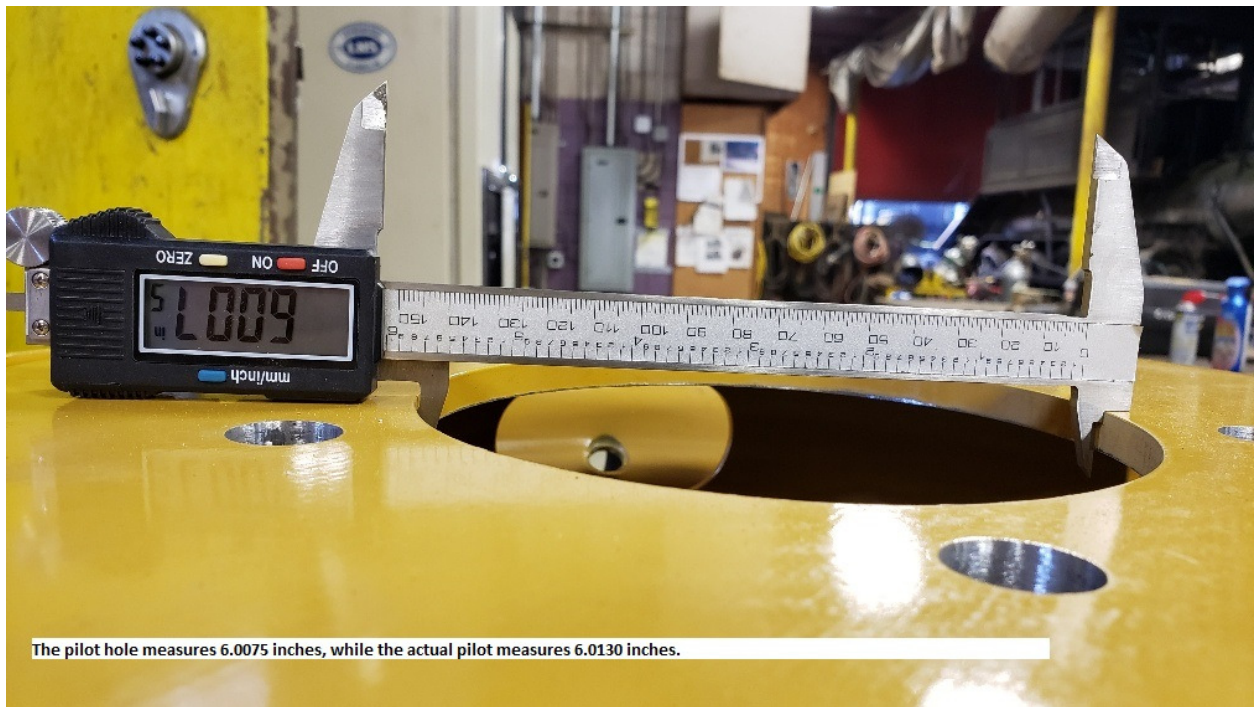
The pilot hole measures 6.0075 inches, while the actual pilot measures 6.0130 inches.

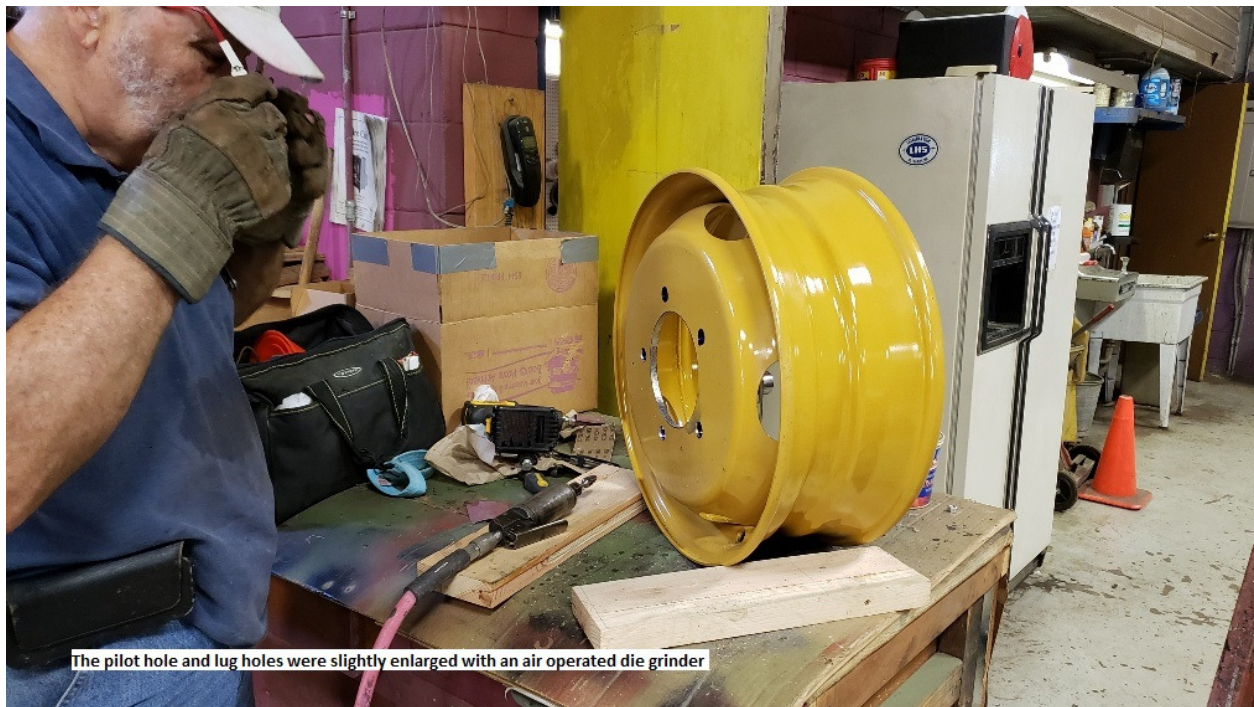
The pilot hole and lug holes were slightly enlarged with an air operated die grinder

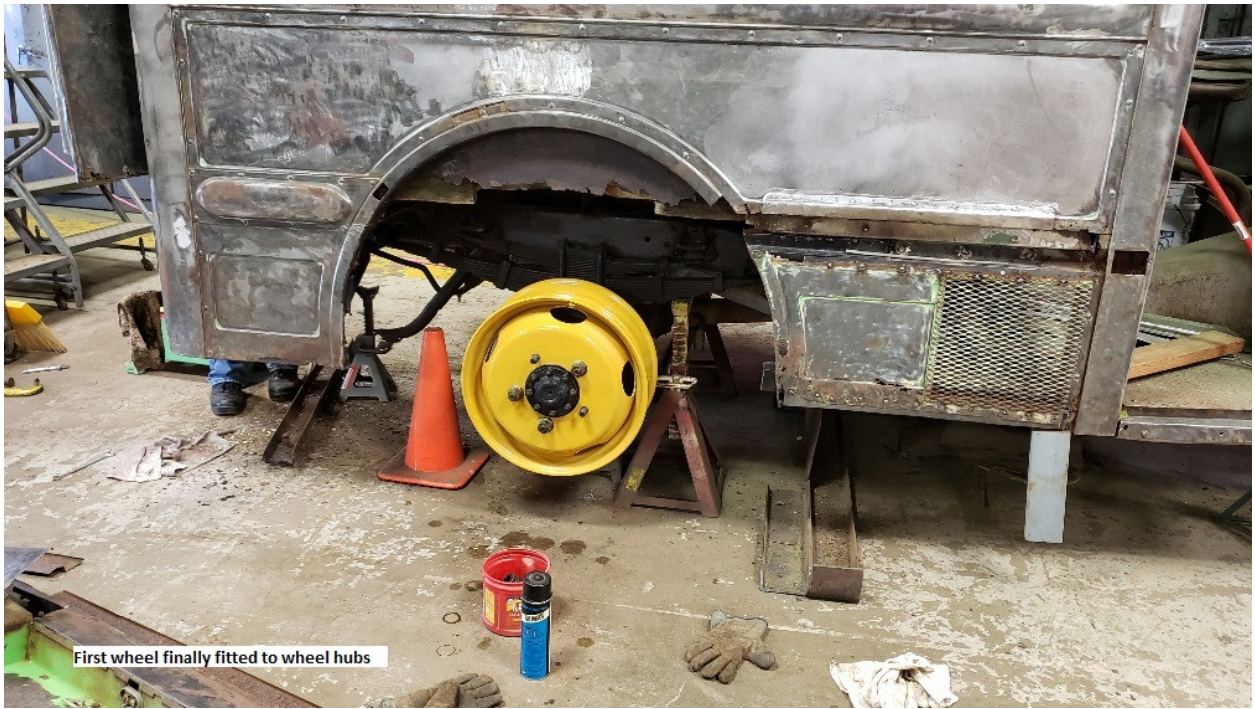
First wheel finally fitted to wheel hubs

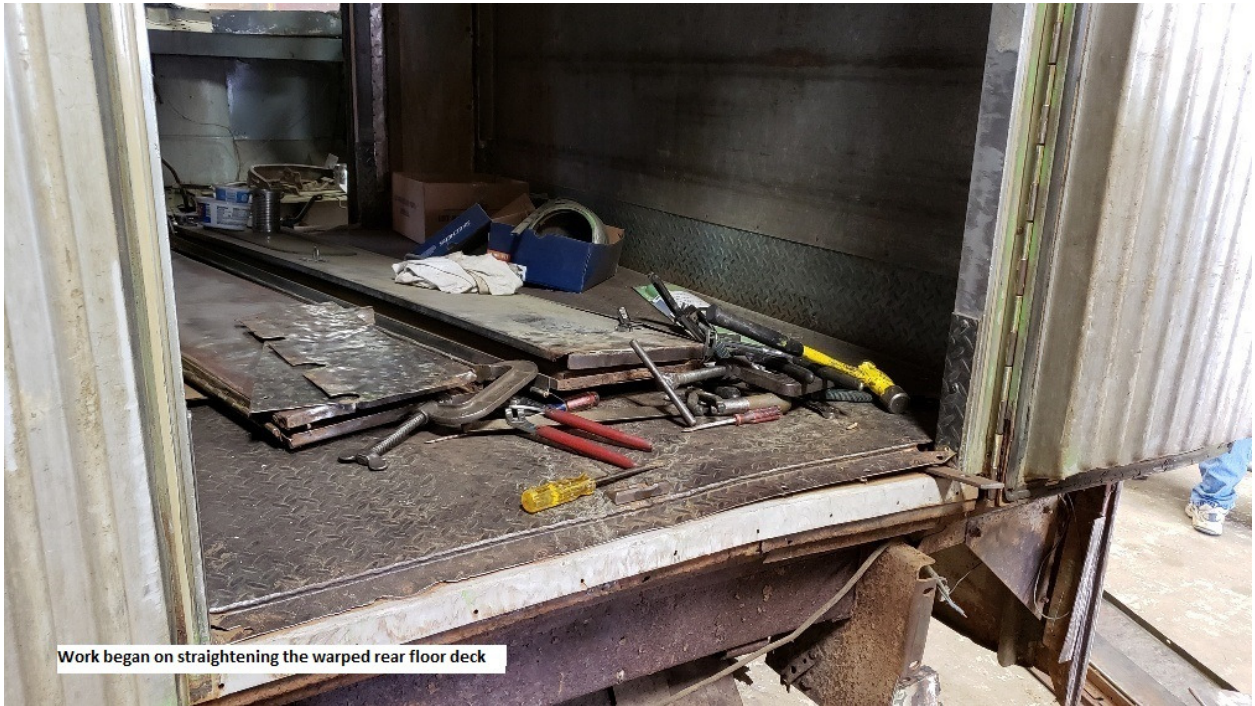
Work began on straightening the warped rear floor deck

Work began on straightening the warped rear floor area of the truck.

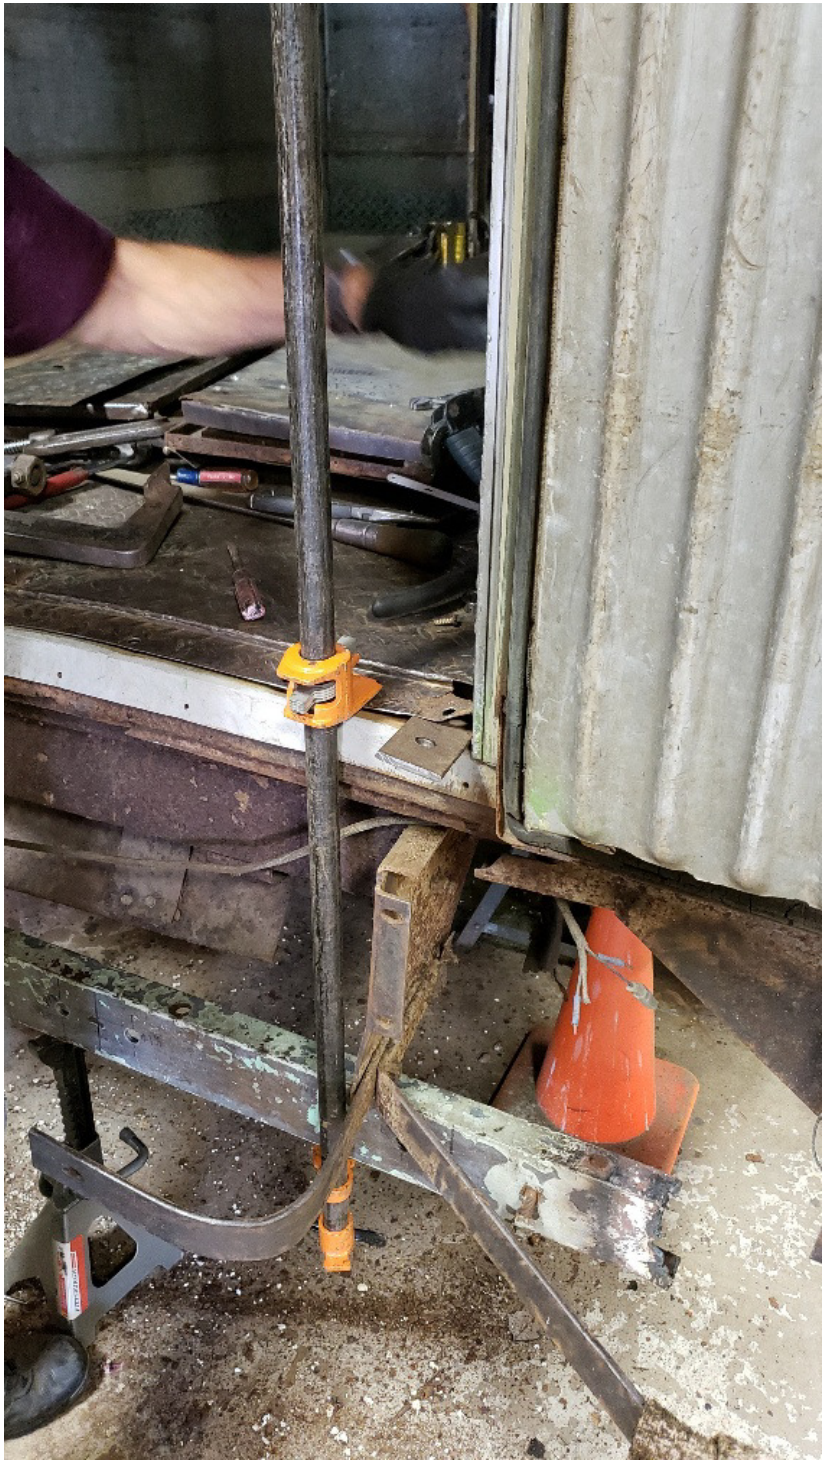
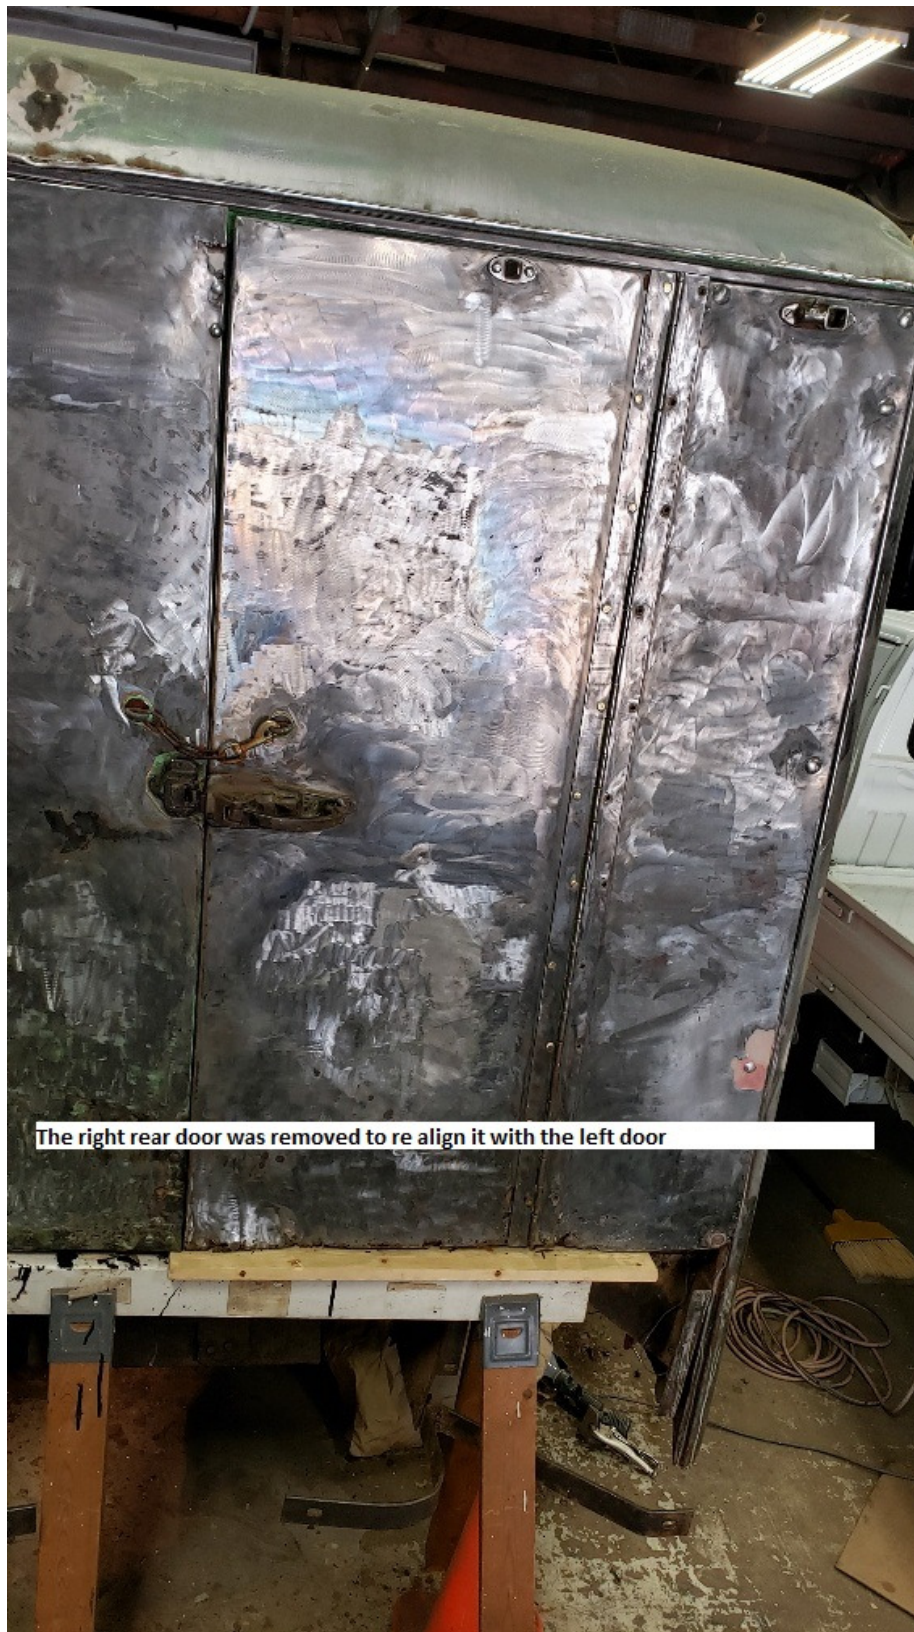
The right (passenger side) rear door was removed, and repositioned to align better with the left (drivers side)rear door. Also, the driver side door latch assembly was removed and repositioned to align better with the passenger side door latch assembly. Further straightening of both doors are needed, as, both are warped outward at the top and bottom.

The right rear door was removed to re align it with the left door

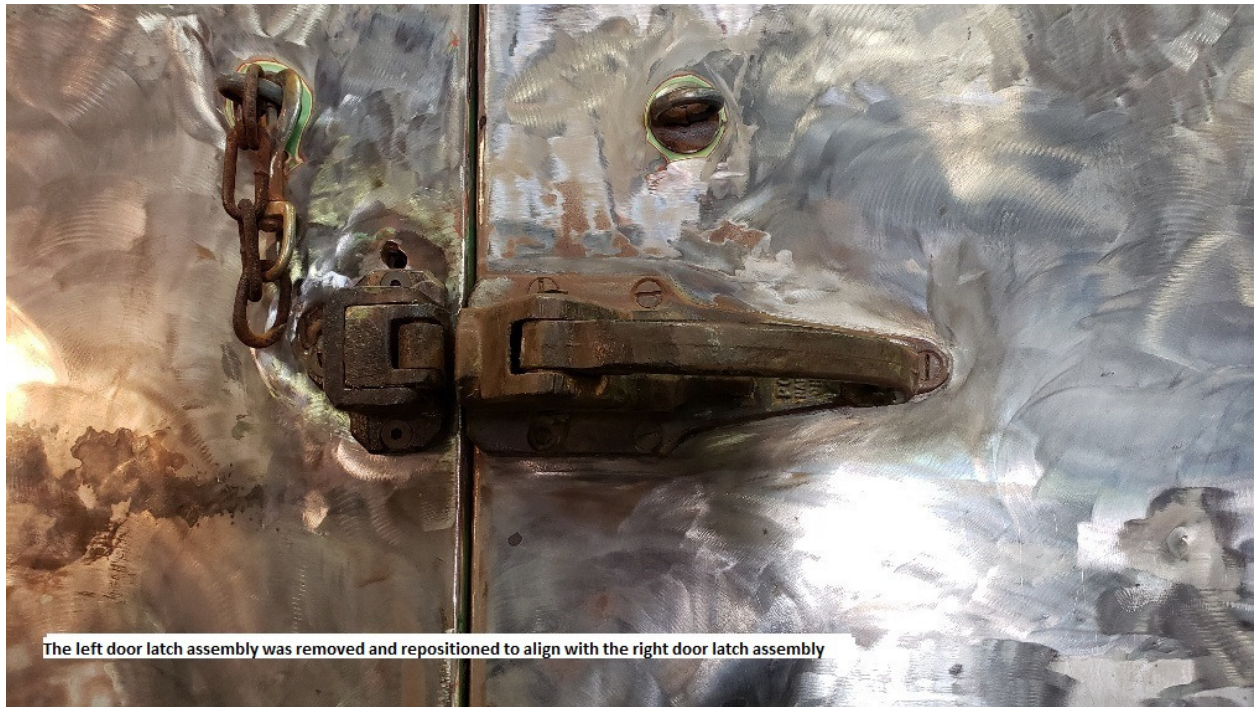
The left door latch assembly was removed and repositioned to align with the right door latch assembly
