Following is the progress report for the Bailey Farm Divco Dairy truck restoration project for the week of 11 August 2019. Please refer to the attached photos. We have also incorporated all photos and this report into a PDF document for ease of review.

Bailey Farms Divco Dairy Truck Restoration Photos Week of 11 August 2019

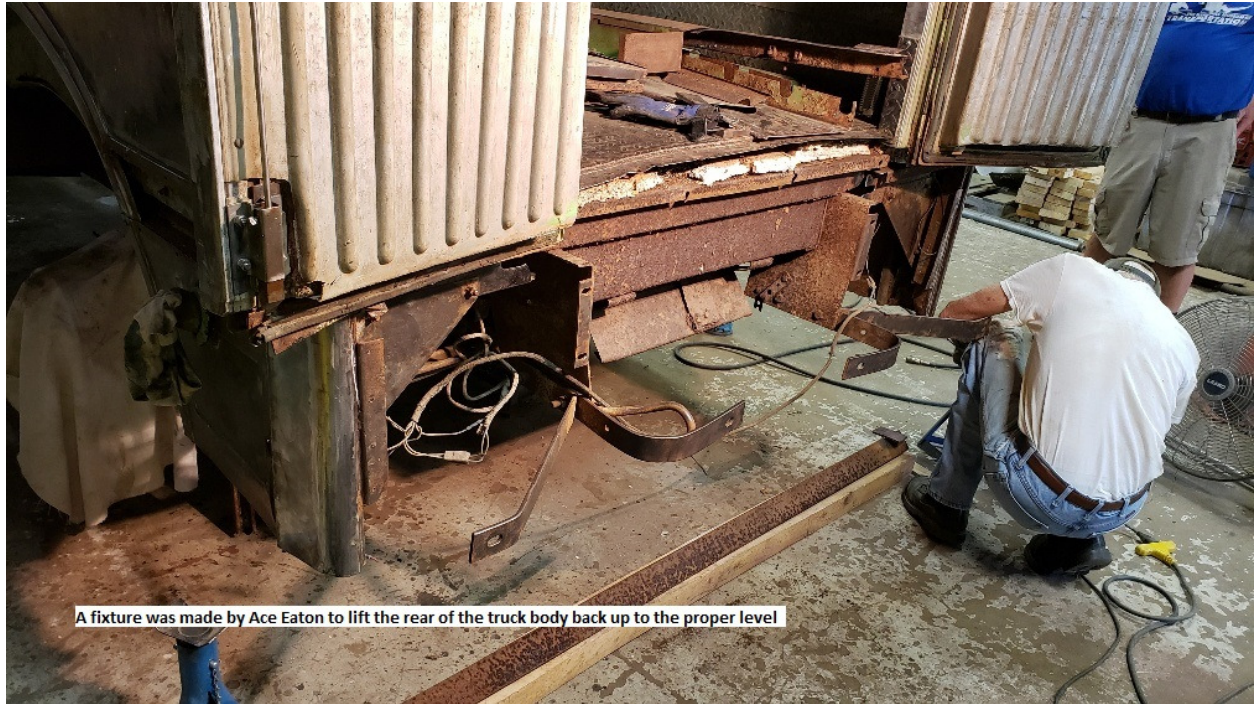
A fixture was made by Ace Eaton to lift the rear of the truck body back up to the proper level

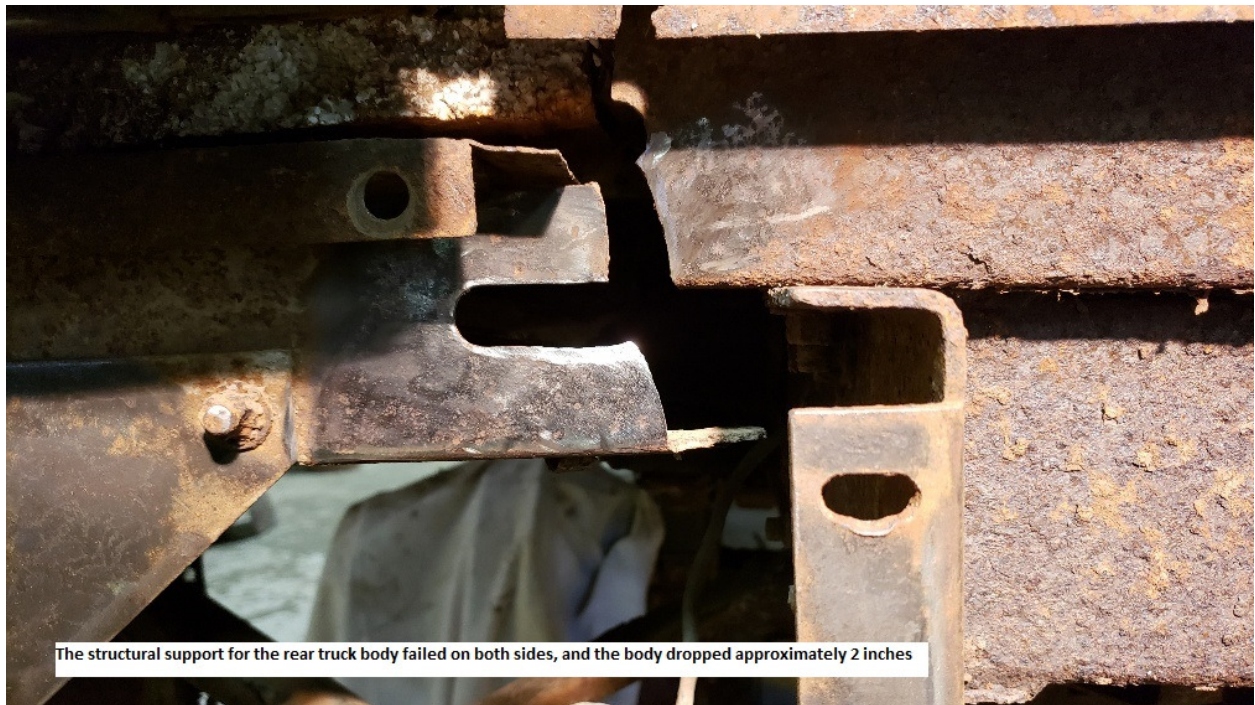
The structural support for the rear truck body failed on both sides, and the body dropped approximately 2 inches

The rear of the truck body was raised back to the proper position and additional structural support was provided to secure the rear of the truck body to the frame. The rear doors close properly now. Some minor alignment of the doors and latches will be required.

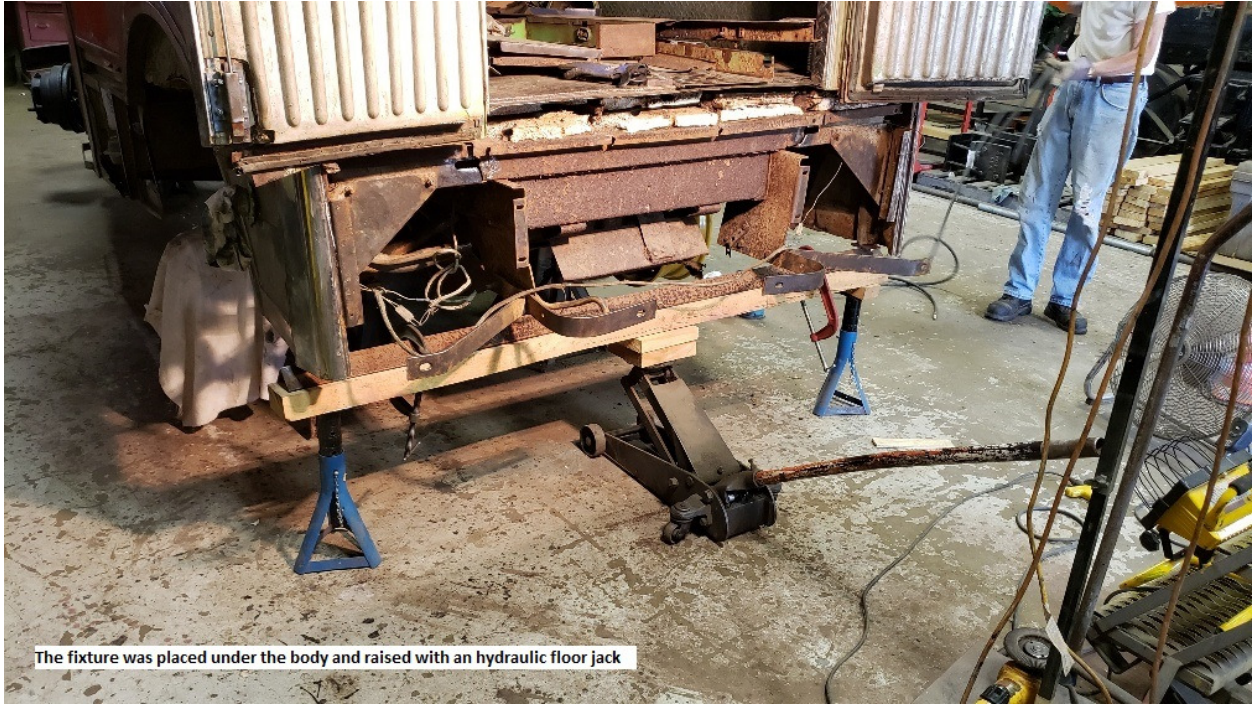
The fixture was placed under the body and raised with an hydraulic floor jack

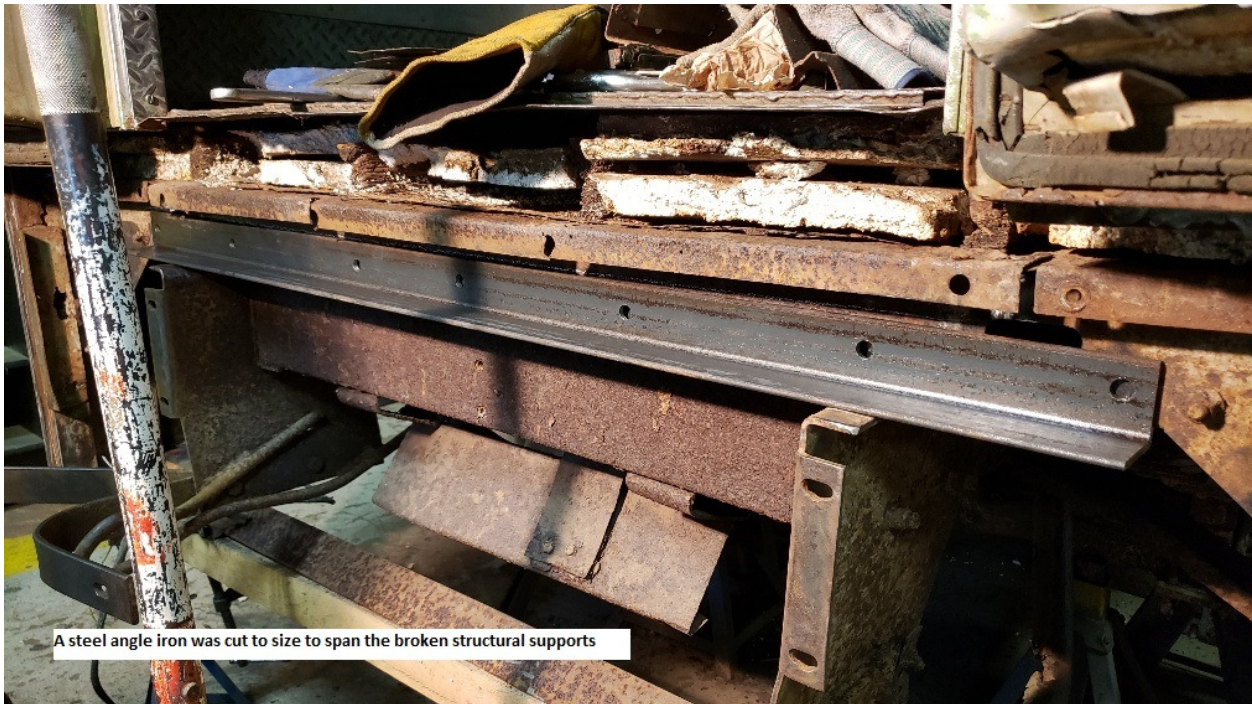
A steel angle iron was cut to size to span the broken structural supports

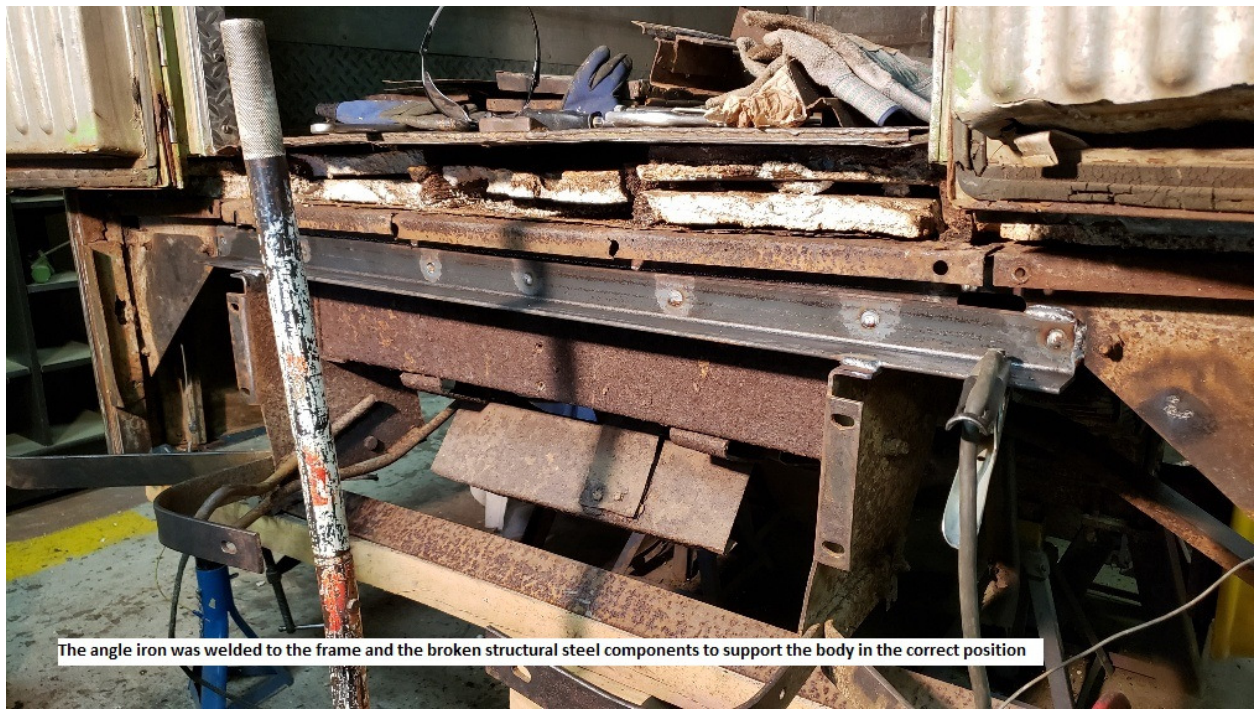
The angle iron was welded to the frame and the broken structural steel components to support the body in the correct position

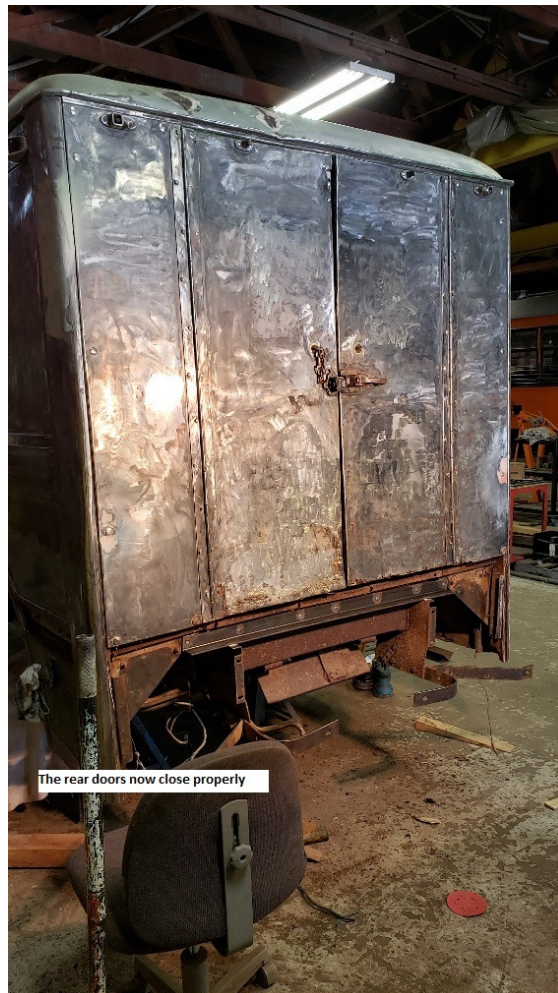
The rear doors now close properly

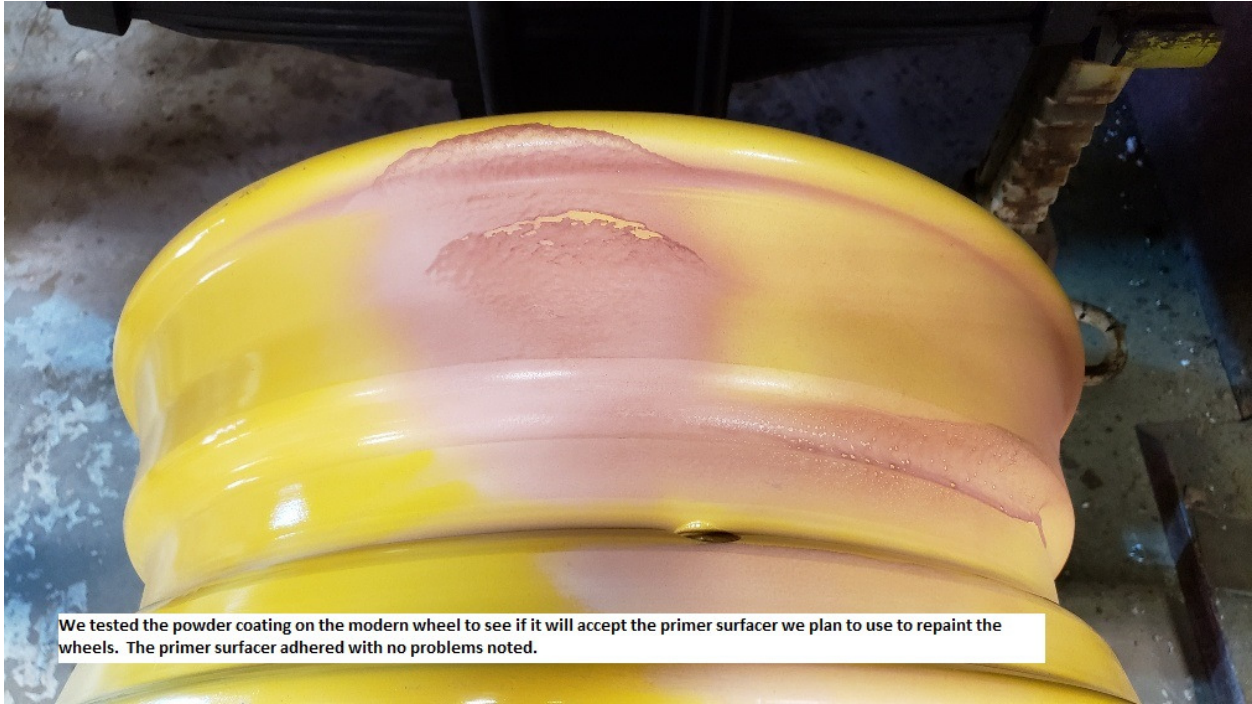
We tested the powder coating on the modern wheel to see if it will accept the primer surfacer we plan to use to repaint the wheels. The primer surfacer adhered with no problems noted.

It was decided that the yellow color of the new modern wheel will not work with the original color scheme. We did a test on the wheel to see if the primer surfacer we will use will properly adhere to the powder coating and not flake. The test was positive and no problems with adhesion were noted. It is planned to paint the new modern wheels the same color as the body.

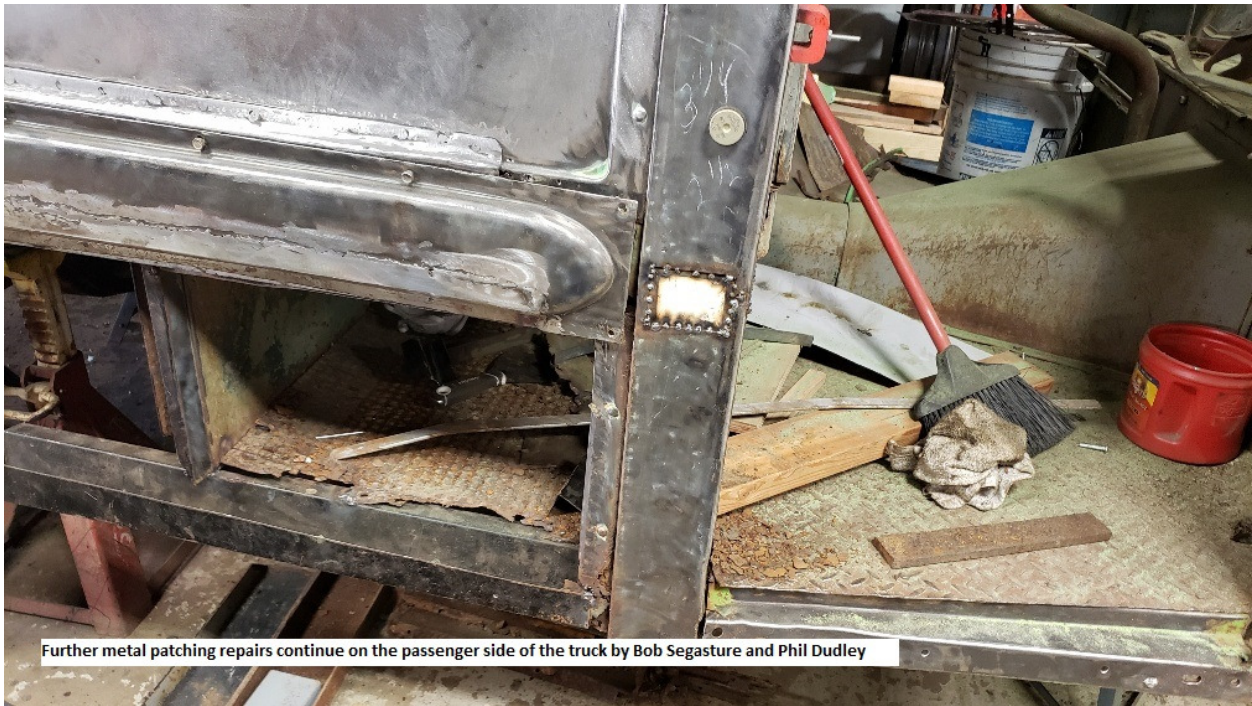
Further metal patching repairs continue on the passenger side of the truck by Bob Segasture and Phil Dudley

Metal patches are being welded to the passenger side of the truck. Bondo activities will commence once all metal patches are in place.

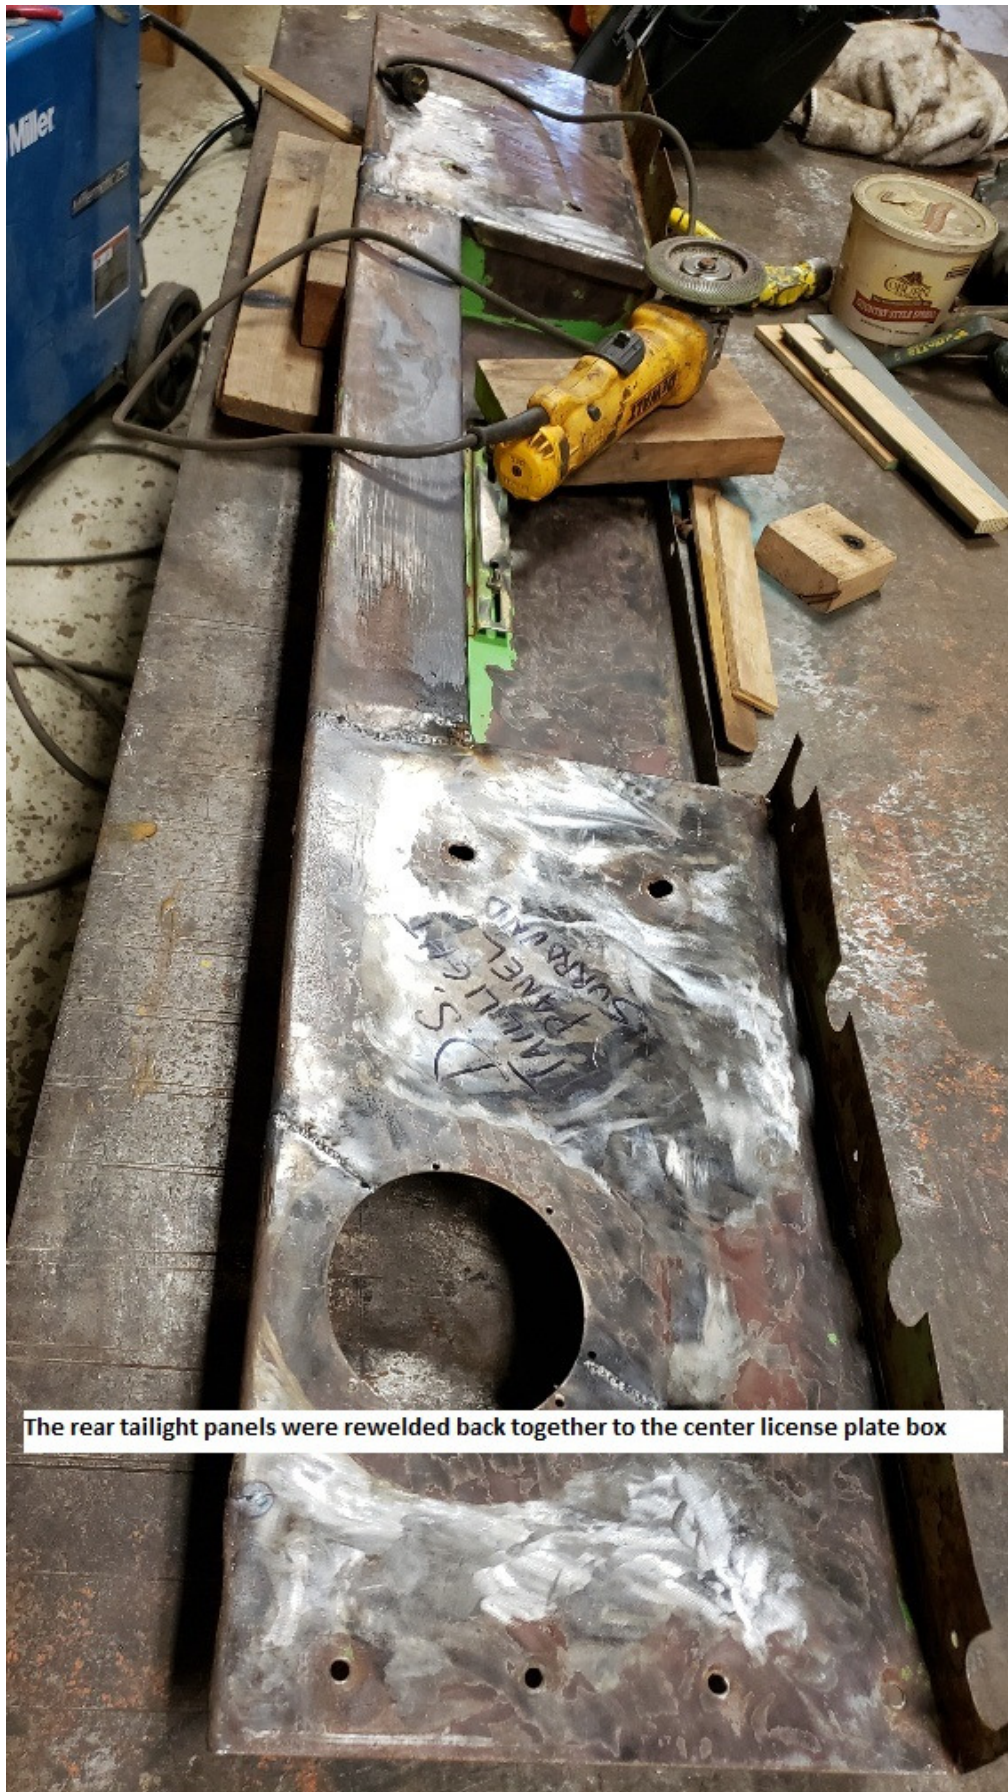
The rear taillight panels were rewelded back together to the center license plate box

The rear tail light panels were rewelded back together to the center license plate box

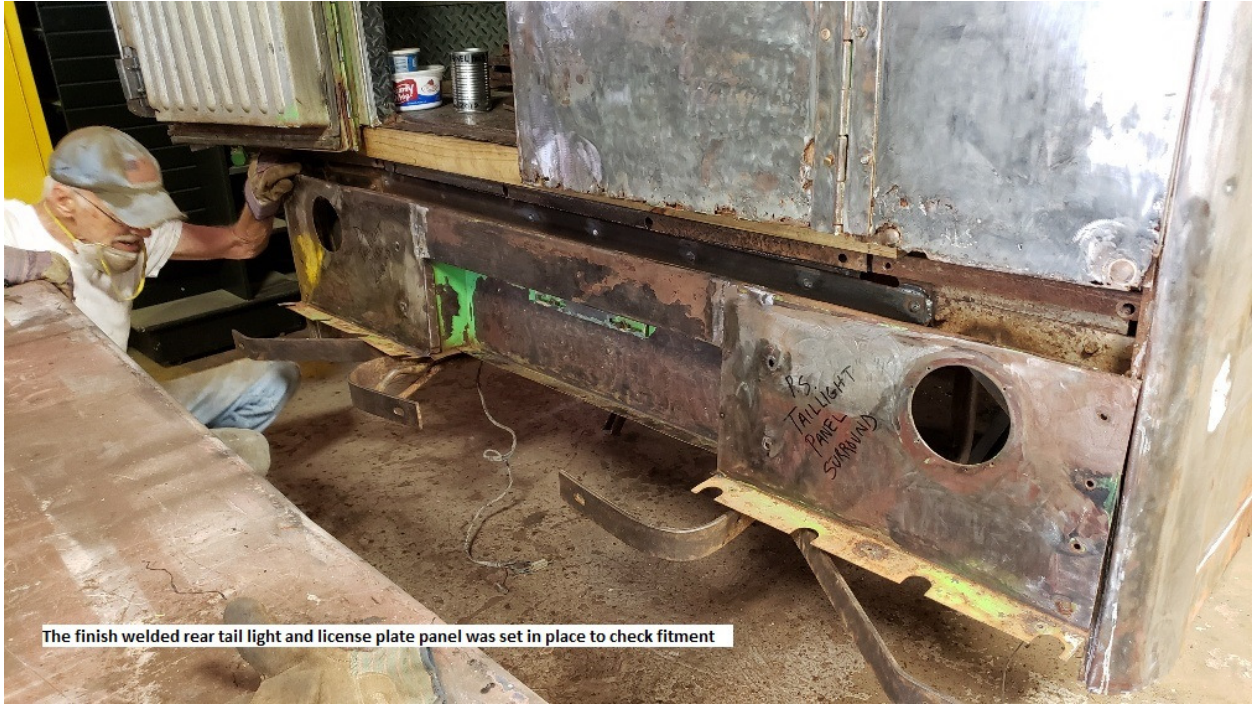
The finish welded rear tail light and license plate panel was set in place to check fitment

The rear tail lights and license plate panel were re welded back together and placed back on the rear of the truck to check fitment. We plan to rust reform all of the steel behind the panel before we permanently attach it back onto the truck.
