Following is the progress report for the Bailey Farm Divco Dairy truck restoration project for the week of 4 August 2019. Please refer to the attached photos. We have also incorporated all photos and this report into a PDF document for ease of review.

## Bailey Farms Divco Dairy Truck Restoration Photos Week of 4 August 2019

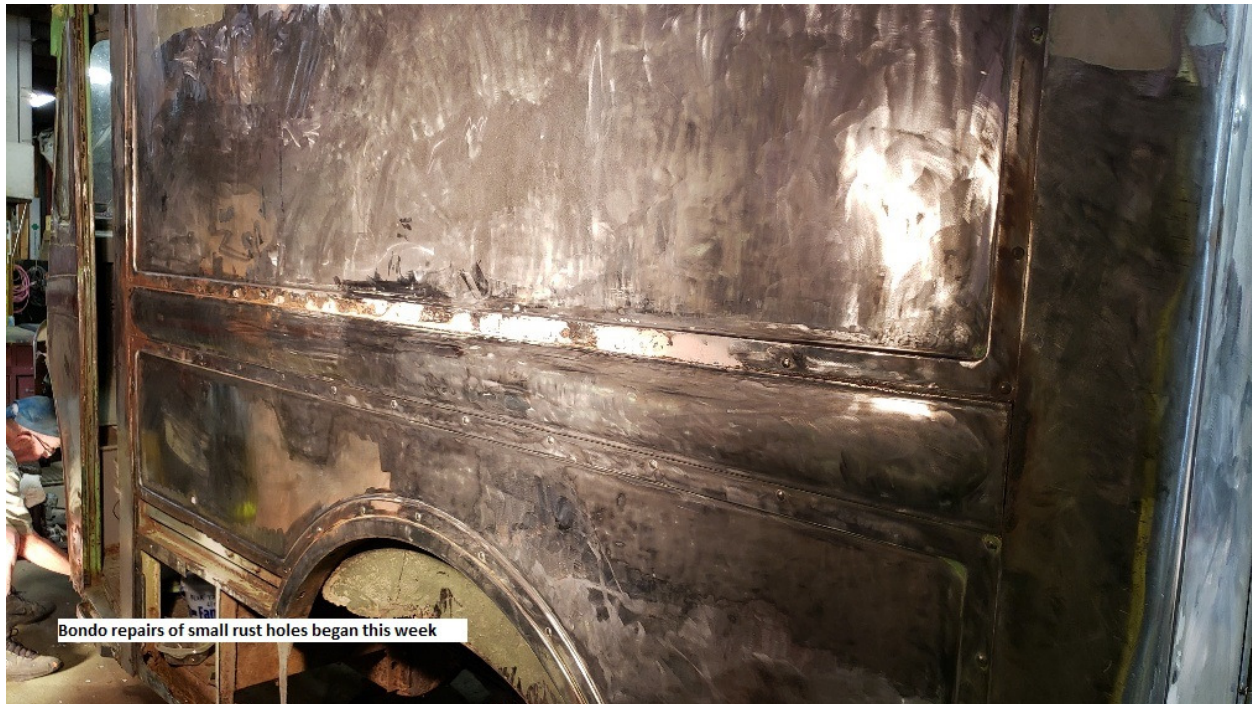
We began Bondo repairs to small rust holes on the drivers side of the truck

Bondo repairs of small rust holes began this week

**Bondo repairs of small rust holes began this week**

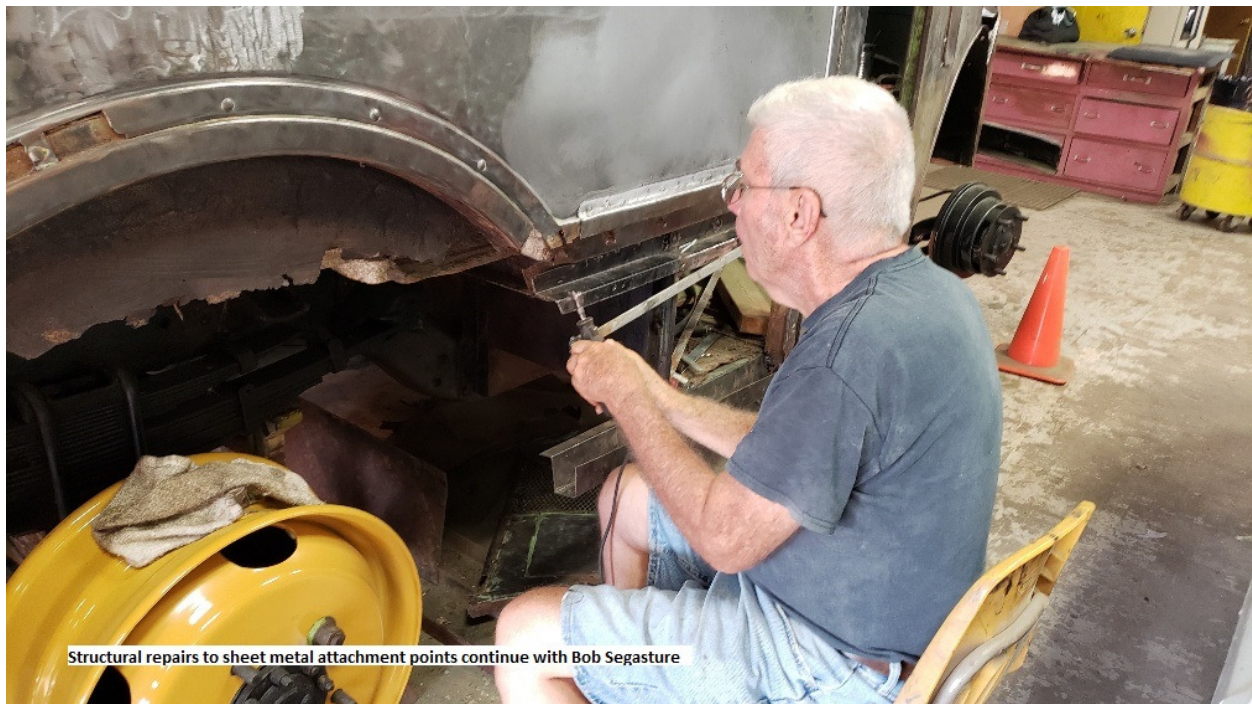
Structural repairs to the sheet metal attachment points on the passenger side continue at this time.

Structural repairs to sheet metal attachment points continue with Bob Segasture

**Structural repairs to sheet metal attachment points continue with Bob Segasture**

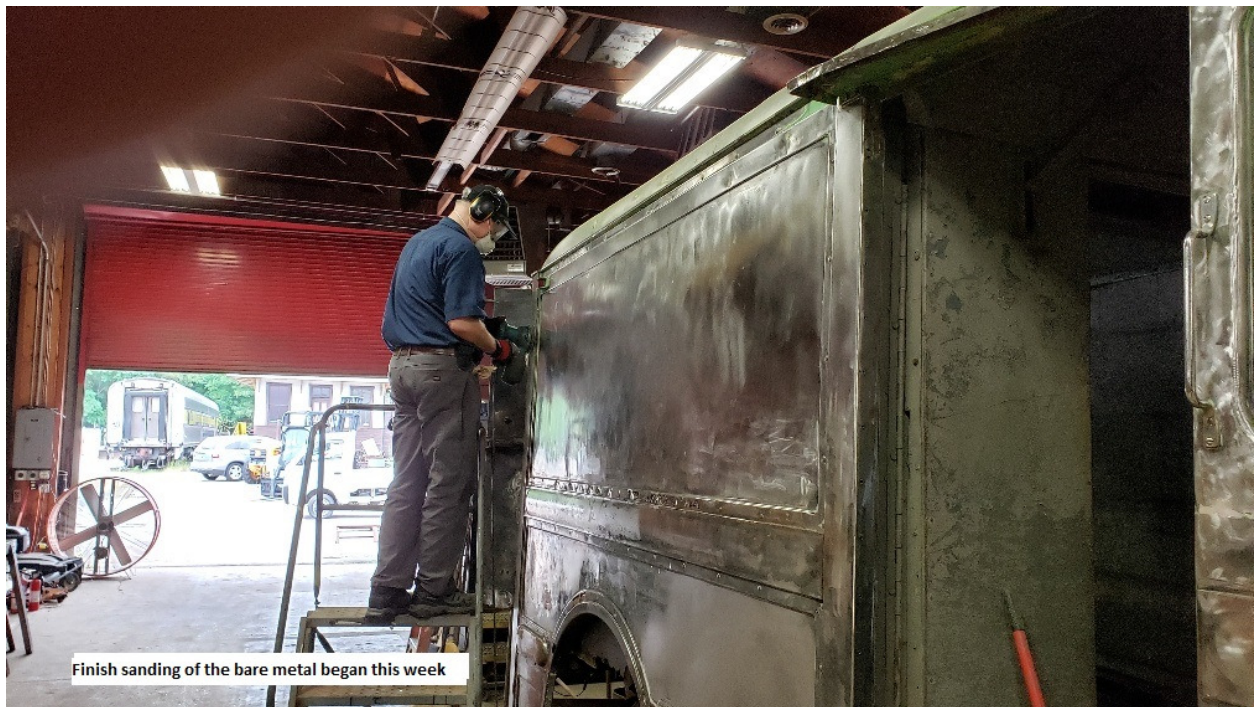
Final finish sanding of the bare sheet metal on the passenger side began this week, as well. Additional bondo repairs and the continuing structural repairs to the sheet metal attachment points will continue for awhile.

Finish sanding of the bare metal began this week

**Finish sanding of the bare metal began this week**

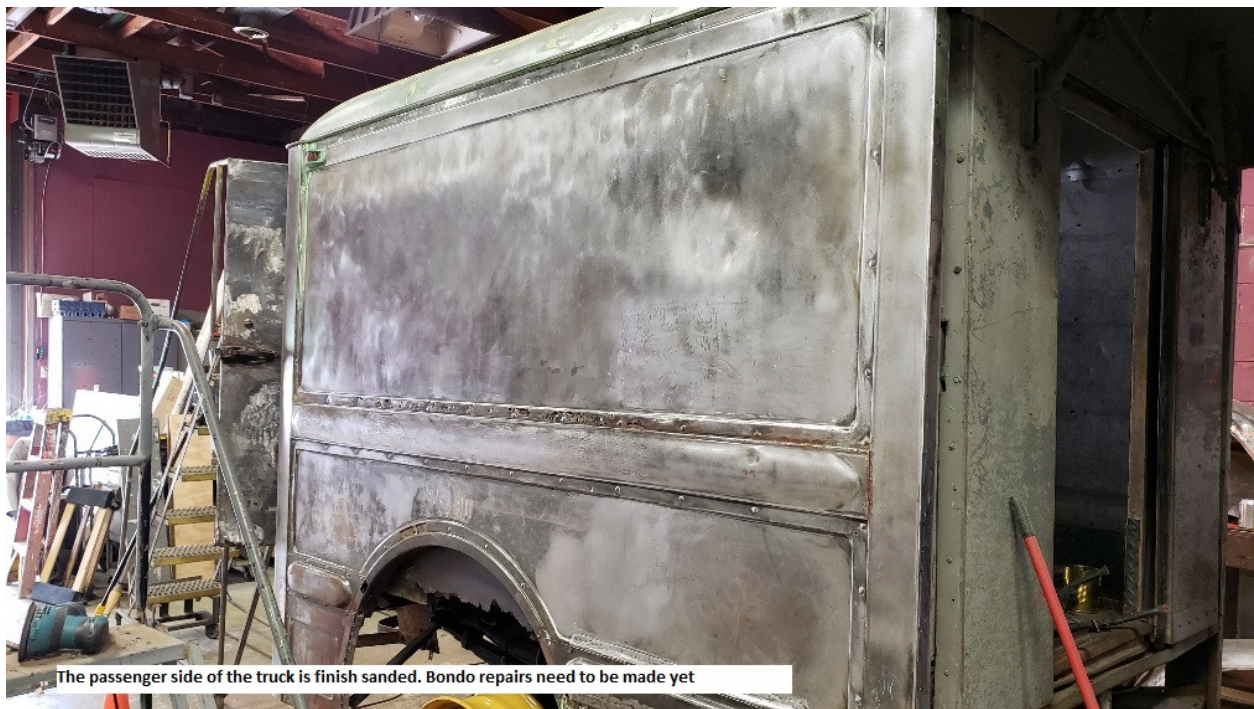
The passenger side of the truck is finish sanded. Bondo repairs need to be made yet

**The passenger side of the truck is finish sanded. Bondo repairs need to be made yet**

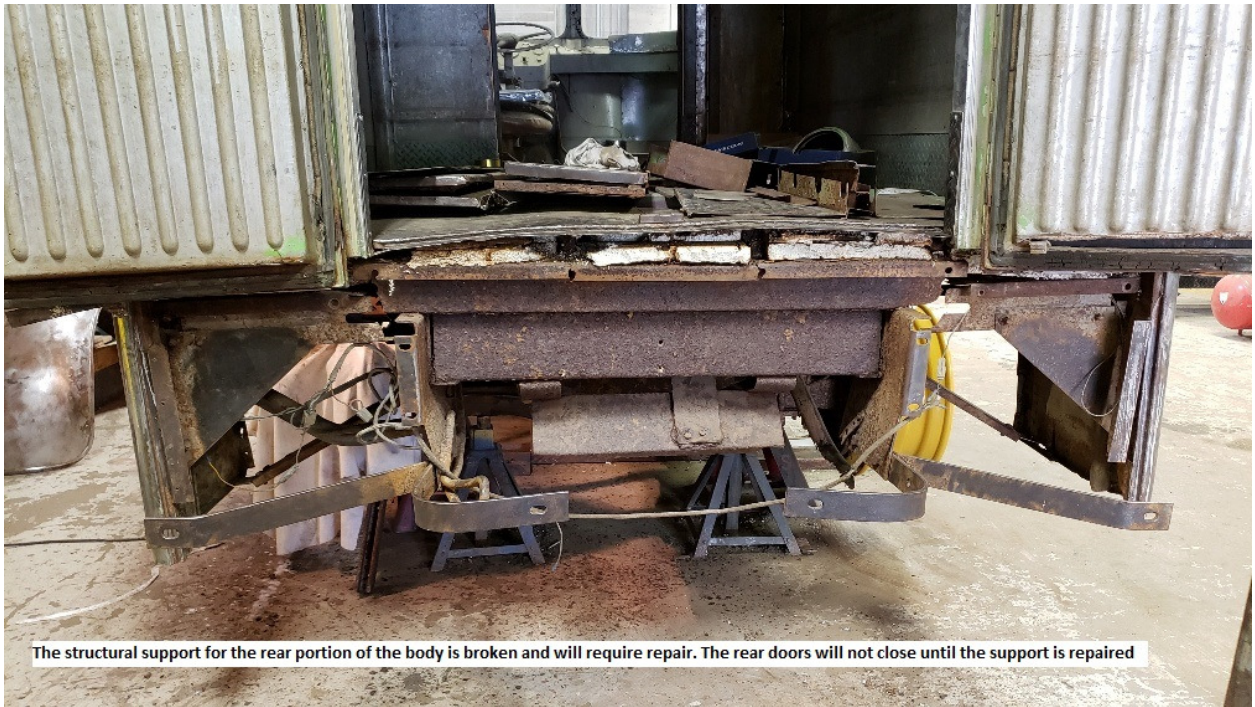
We discovered that the rear of the truck body was sagging, and preventing the rear doors to close properly. Upon further investigation, we found that the steel structural support which holds the rear of the truck body to the frame was crack through on both sides. The rear of the truck body is being supported solely by the diamond plate metal flooring inside the truck at this time. We have temporarily supported the rear of the truck body with floor jack stands until we can raise the body back to the correct position and install additional structural supports. We will make this repair a priority, with the help of Bob Segasture, and Phil Dudley this coming week.

The structural support for the rear portion of the body is broken and will require repair. The rear doors will not close until the support is repaired

After repair of the rear of the truck is completed, we will concentrate on bondo repairs, and readying the truck for final sanding and priming activities. We will also work on cleanup and priming of the interior of the truck and engine compartment soon.

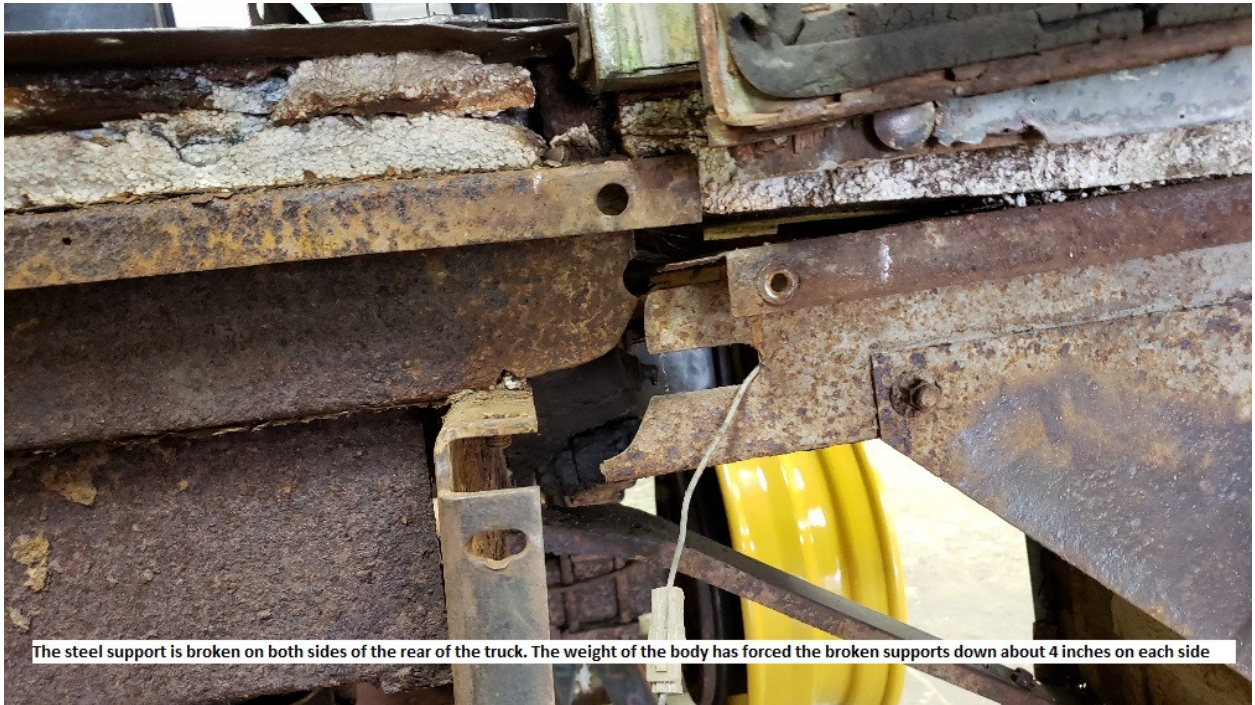
The steel support is broken on both sides of the rear of the truck. The weight of the body has forced the broken supports down about 4 inches on each side

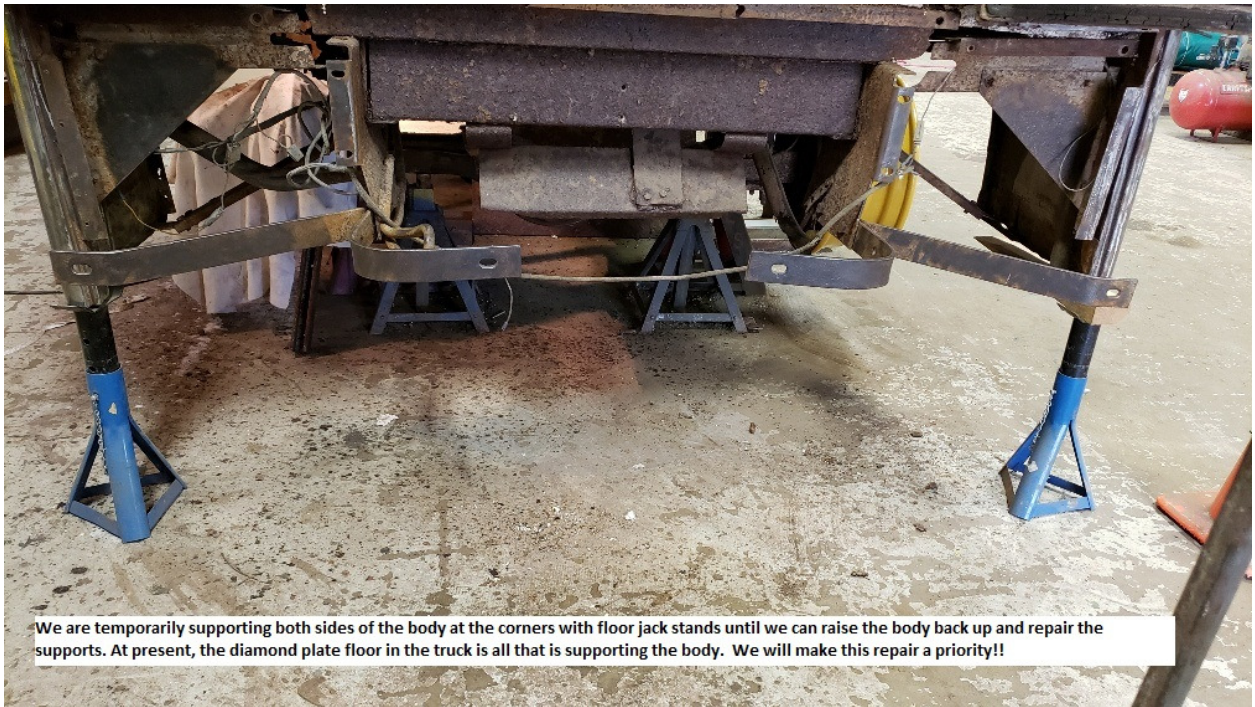
We are temporarily supporting both sides of the body at the corners with floor jack stands until we can raise the body back up and repair the supports. At present, the diamond plate floor in the truck is all that is supporting the body. We will make this repair a priority!!

**We are temporarily supporting both sides of the body at the corners with floor jack stands until we can raise the body back up and repair the supports. At present, the diamond plate floor in the truck is all that is supporting the body. We will make this repair a priority!!**
